The Nihoku Ecosystem Restoration Project:  
A case study in predator exclusion fencing, ecosystem restoration, and seabird translocation

March 2018

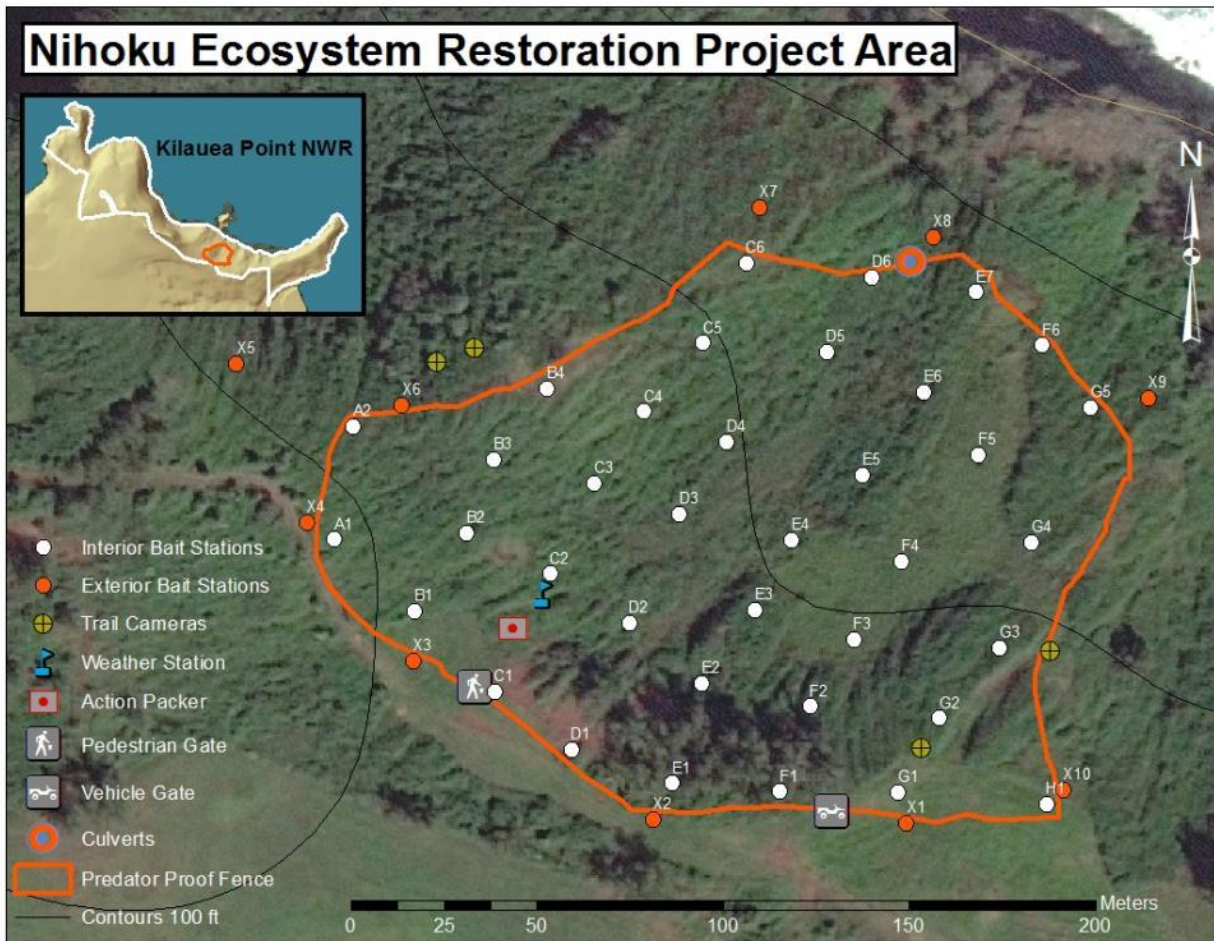
**Figure 2:** Nihoku fence monitoring grid with final fence line.

To facilitate consistent, repeatable monitoring for a variety of species, a geo-referenced, 50 m interval grid oriented on magnetic north was installed (Figure 2), with points marked by white PVC with a 10 cm reveal. The rationale for selecting a 50 m grid was to provide an adequate number of replicates within the fenced area (N=14) for ecological comparisons and to have appropriate spacing for rodent bait stations, since 50 m is the average home range size for Black Rats (VanderWerf et al. 2014). The grid consists of stations inside the fence (experimental) and outside the fence (control) spaced every 50 m, resulting in 14 points inside the fenced area and 10 outside. With the exception of bird species, all biological monitoring was done using these grid points.

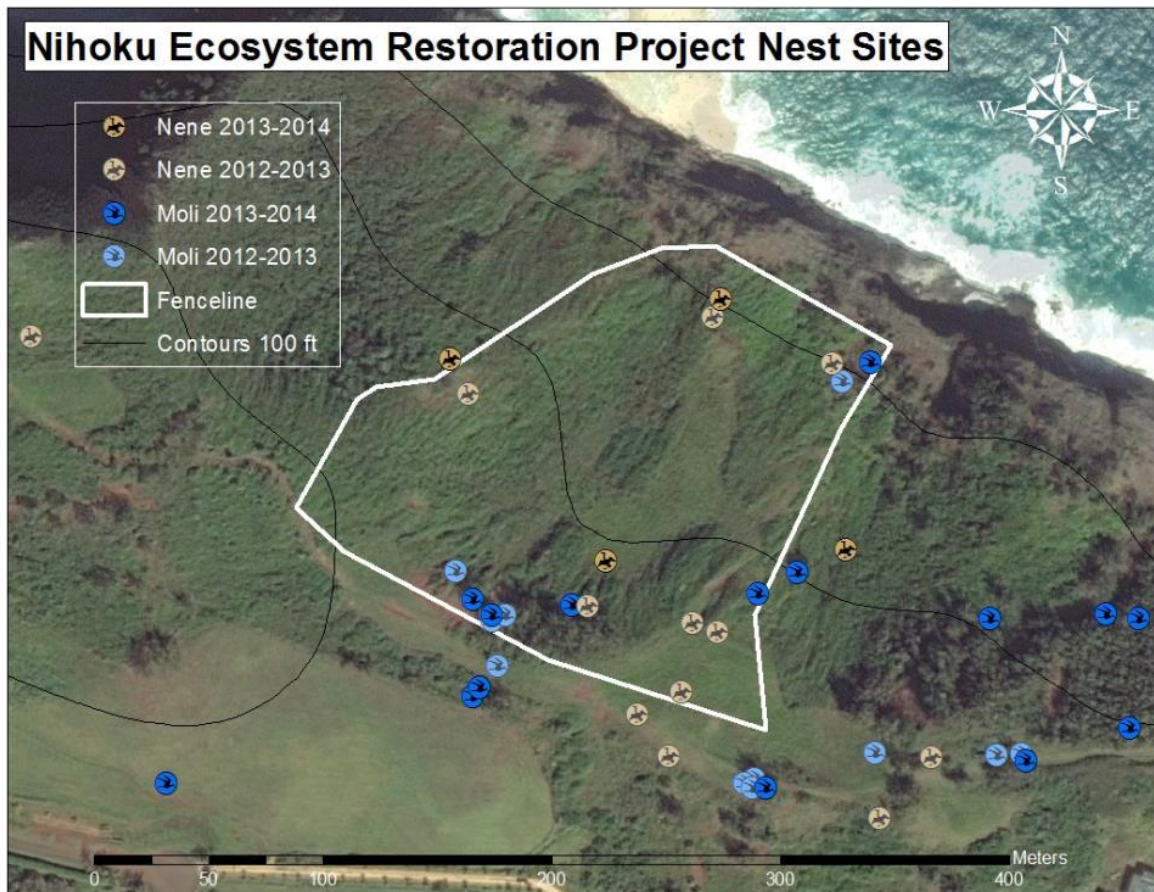
**Figure 4.** Native bird nests recorded at Nihoku from 2012-2014, with initial proposed fence line.

In 2014, a total of two Nēnē nests and five Laysan Albatross nests were found within the proposed fence area (Figure 4). Neither Newell's Shearwater nor Hawaiian Petrel were detected during auditory surveys or with song meters, but numerous Wedge-tailed Shearwaters were detected, from birds nesting outside the project area (Figure 5). In addition, two Kermadec Petrels (*Pterodroma neglecta*; KEPE), which breed in New Zealand and the southern hemisphere, were seen regularly flying through the project area, vocalizing frequently and potentially doing courtship flights. While there are not any records of Kermadec Petrels nesting in Hawai'i, the behavior they exhibited during these surveys suggested they may be prospecting for nesting locations if they were not nesting already. This species has been recorded in previous years at KPNWR, and has occurred regularly at KPNWR throughout the breeding season for the last four years. Barn Owls were detected sporadically in small numbers.

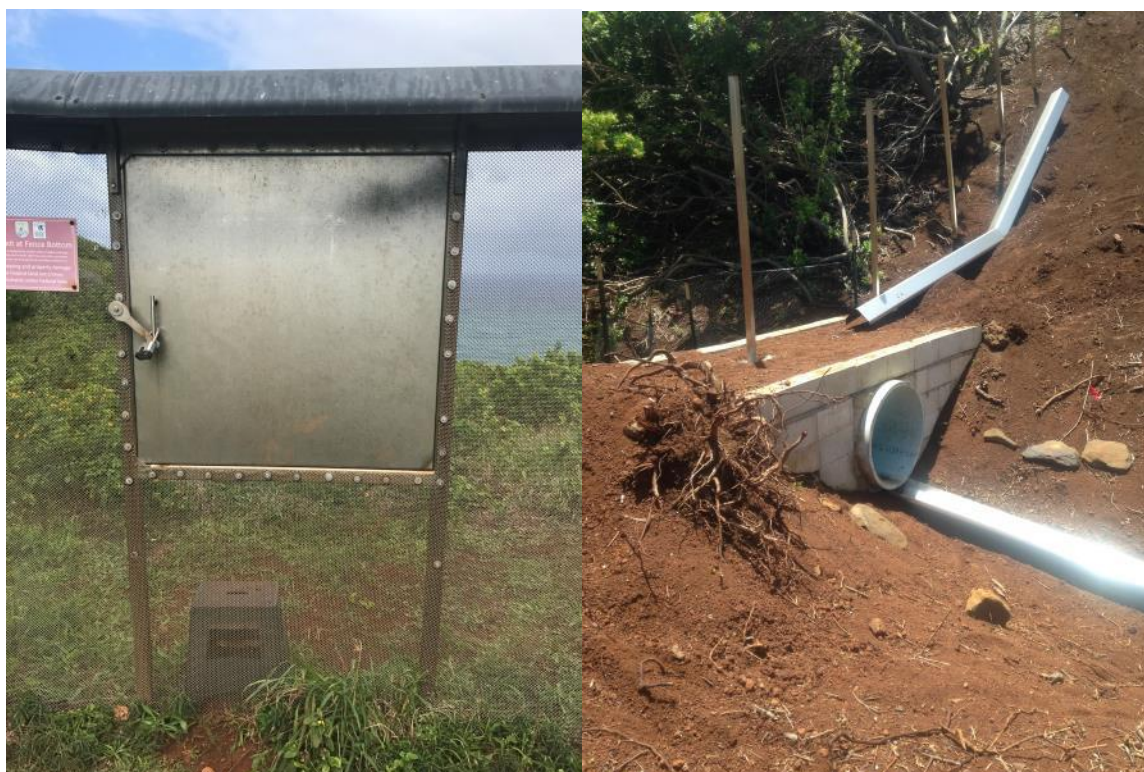
**Figure 14:** Nihoku pedestrian gate (left) and culvert (right). The culvert is shown during construction. Fence exterior is on the right; mesh was placed over the inside of the culvert opening to prevent debris from getting into the culvert and to prevent rodents from entering.

A single culvert was installed at the bottom (north) end of the fence where there was a natural ephemeral drainage feature. Despite little evidence of regular running water, it was clear that water did occasionally flow during periods of high rain. A three-foot-wide PVC tunnel was installed under the fence line, and cinderblock tiles were used to fill in the space around the culvert. Once it was complete, the fence was built overtop of the culvert, cemented in place, and a mesh screen was installed over the culvert openings to ensure it remained pest proof.

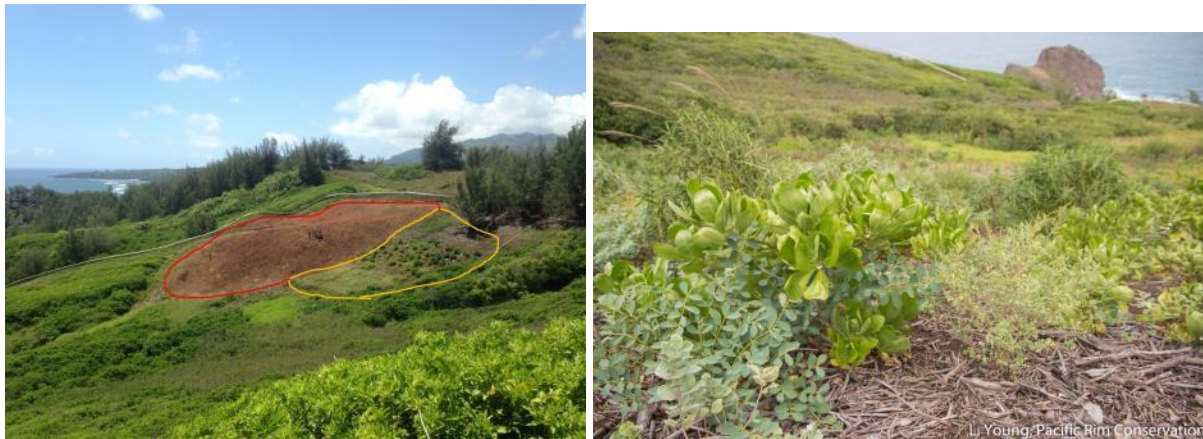
**Figure 20:** Nihoku restoration areas, the yellow line indicates the area cleared and revegetated in 2015, the red line indicates the area cleared in 2016. On the right are native plants from the 2015 planting cohort.

Almost 1.2 ha (3 ac) were cleared of invasive weeds and close to 18,000 native plants representing 36 species were out-planted in the first three years of restoration at Nihoku. While there was some mortality associated with trampling around the artificial burrows and Nēnē browsing, it is estimated that greater than 50% of outplanted seedlings survived and are covering the majority of the cleared area. Active weeding is done quarterly to ensure that restoration areas remain native-dominated. In future years, more shrubs will be planted for better cover, and an attempt will be made to determine a better age for outplanting key Nēnē forage species so that the Nēnē don't inadvertently kill the plants (from over-browsing) before they establish. In total, approximately 40% of the project area was restored from 2015-2017, and restoration efforts will continue in future years.

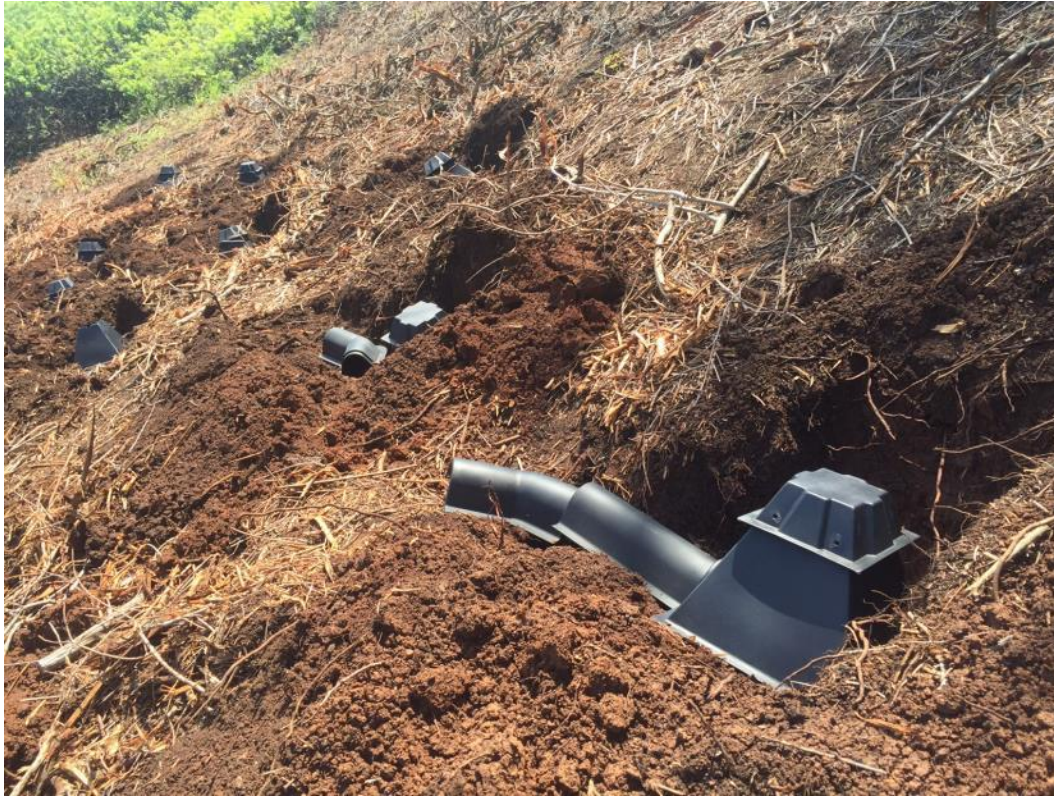
**Figure 22:** Nihoku artificial burrows prior to being installed.

Standard artificial burrow designs used in New Zealand for similar Procellariiformes species are 5-sided wooden boxes (four sides plus a lid) with open bottoms and corrugated plastic PVC tubes for burrow entrances. A similar design is used for NESH, but with a lighter weight plastic that has been used for the tropical nesting Bermuda Cahow and Audubon's Shearwater in the Caribbean.

The nest boxes that were used were manufactured by the Bermuda Audubon Society with 0.3 cm thick High Density Polyethylene (HDPE) and fabricated in a size for accommodating all burrow/cavity nesting seabirds in the weight range 250 – 600g (see attached specifications). HDPE is chemically inert and very durable and the thickness is strong enough to resist warping or physical damage from trampling, tree-fall and rock-fall in most circumstances, especially when buried in soil substrate. The burrows (pictured above) are square boxes measuring 50 x 50 cm and are 38 cm high. They have hinged lids for easy access and a modular tunnel component that can be cut to any length and with 225° angled sleeves to allow the tunnel to make turns (to keep out light). The opening of the tunnel is 15cm in diameter.

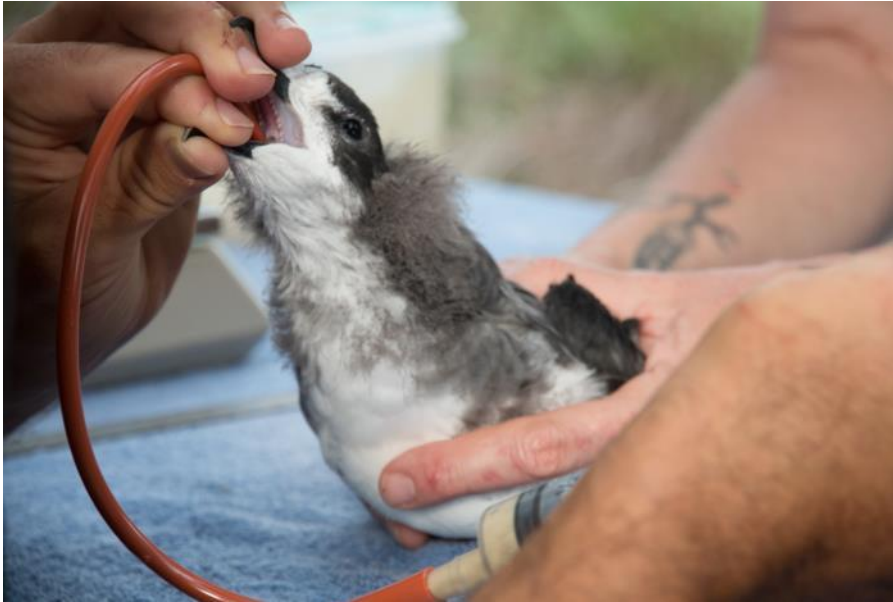
**Figure 22:** Demonstration of proper feeding technique, and apparatus from the 2015 HAPE translocation to KPNWR.

All feeding will be done on a clean surface (folding table) located in the shade above the colony. On rainy days, a pop-up tent will be erected to provide cover. The handler will hold the chick firmly on a surface (with towel) with a loose hand grip—the chick must not be tightly gripped or it will not feed properly and the crop area in particular needs to be unrestricted. The feeder will hold open the bill (mainly grasping the upper bill), stretching the head and neck out (at approx. 30–40° angle from the horizontal). With other hand holding the syringe, the feeder inserts the crop tube to the back and side of the throat (to keep airway clear). Food delivery will be at least 30 seconds for a 40 g batch, with at least one rest approximately half way (c. 20 ml) through syringe load to check for any signs of meal rejection. Food delivery will stop at the pre-determined amount or earlier if there are signs of food coming back up throat. The bill will be immediately released as the crop tube is withdrawn, so that if there is any regurgitation the food can be projected clear of the plumage and risk of aspirating food is reduced.
